FIELD INSPECTION REPORT

Project Name:	Mountain Valley Pipeline	Inspector:	Matthew Grant
Inspection Date:	Tuesday, August 25, 2020	Project Contact:	Brian Clauto
Spread H: Roanoke Franklin	MP 245.9-246, 246.2, 246.5-246.8, 239.2-239.3 AR FR 289, 279.01 ATWS 1307, 1308, 954, 1224, 1225, 968, 1329	Weather:	Dry

FIELD INSPECTION PHOTO LOG

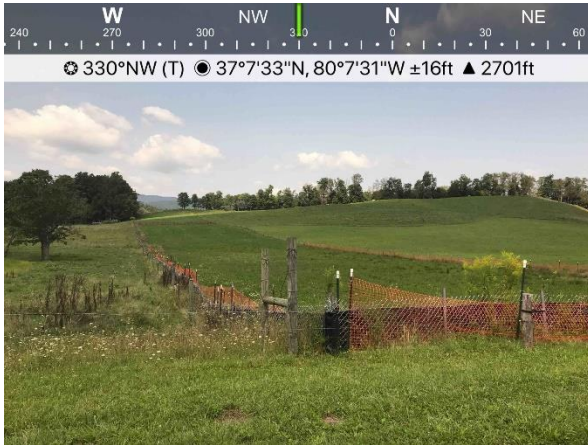
- Figure 1: Near Mp246.2 Blueridge Parkway Crossing, the area is stabilized and ECD's are in place.

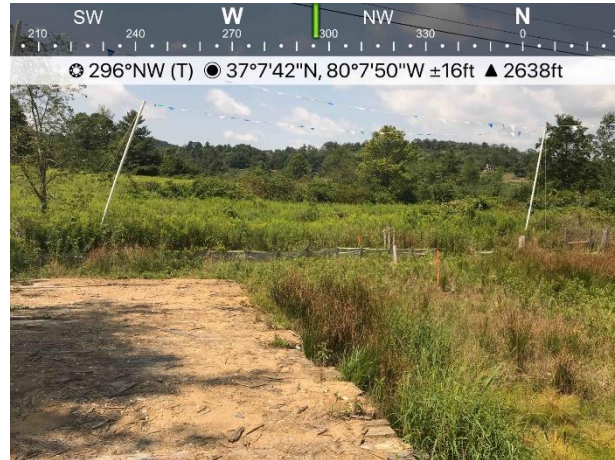
- Figure 2: Near MP 245.9 at designated crossing wetland W-B24-PEM, ECD's are in place and functioning.

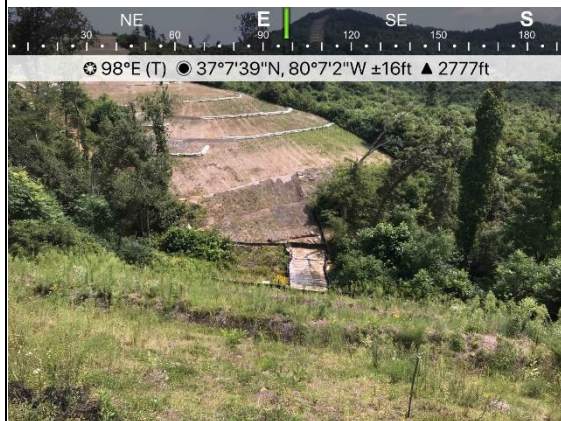
- Figure 3: Stabilization and ECD's are in place and functioning near MP 246.8

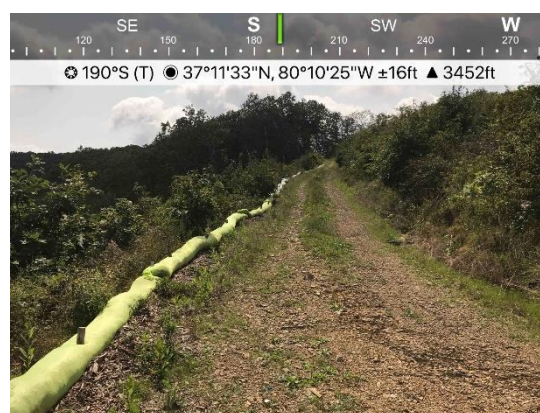
- Figure 4: Access Road RO 279.01 ECD's are in place and functioning.
